Installation, Maintenance & Troubleshooting instruction

Installation Instructions

CAUTION: Installation of Model 500HLR must be performed by qualified, licensed personnel. Faulty installation could result in an improperly functioning device.

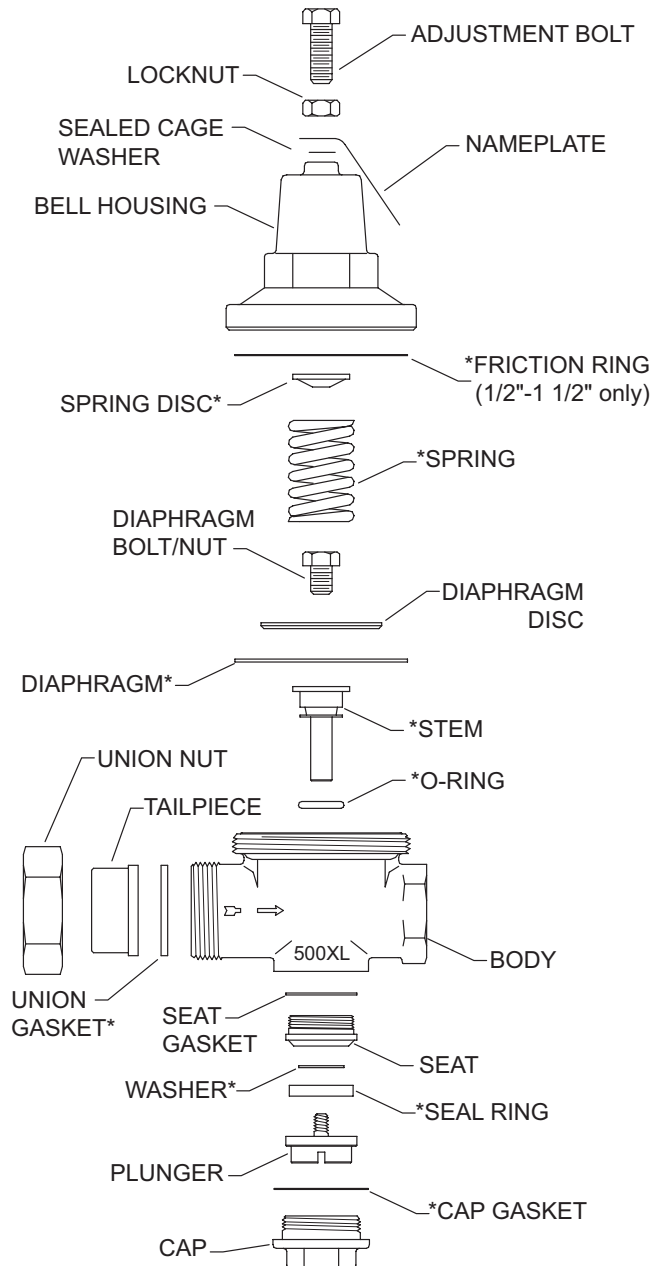
1. Open faucet or hose bibb in dwelling to remove line pressure.
2. Note distance that adjustment bolt protrudes from bell housing. Loosen locknut on adjustment bolt, then turn adjustment bolt out of bell housing until free of spring tension.

3. Loosen cap and remove counterclockwise.
4. Loosen plunger and remove counterclockwise. Remove old seal ring then insert new seal ring.
5. Loosen strainer cap counterclockwise and remove screen.

6. Unscrew bell housing counterclockwise and remove spring, spring disc and friction ring.
7. Remove stem assembly from regulator. Inspect area in body where stem o-ring guides for pitting or scratches. Smooth bore with emery cloth if needed. This area must be smooth for the valve to function correctly.

8. Disassemble stem unit by holding stem securely while removing diaphragm bolt/nut. Discard old stem and diaphragm. Retain diaphragm disc and diaphragm bolt/nut for use on new stem.

1. Open shut-off valve slowly and flush body and line of any debris.
2. Assemble new stem unit using new stem, o-ring, diaphragm, diaphragm disc and diaphragm bolt/nut. Tighten bolt/nut securely (**CAUTION:** Be sure the rounded edge of the diaphragm disc is next to the diaphragm).

3. Lubricate o-ring with grease supplied in repair kit and install stem unit in body. Install new spring, spring disc & friction ring.
4. Replace bell housing by tightening clockwise. Turn adjustment bolt clockwise until adjustment bolt touches spring disc.

5. Center washer on stem. Screw plunger into stem unit (**CAUTION:** Do not over tighten plunger; it is possible to break threaded end of plunger).
6. Install new cap gasket and replace cap by tightening clockwise.

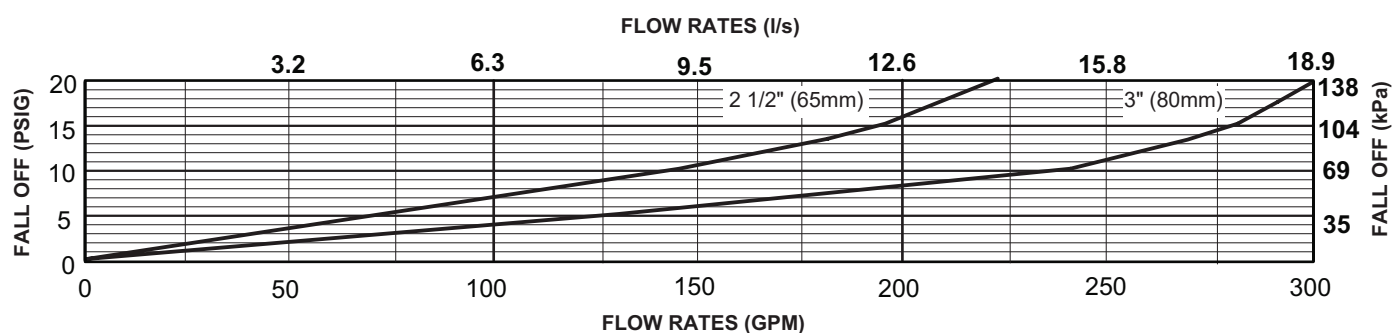
Flow characteristics

MODEL 500HLR(FL) 65 & 80mm (STANDARD & METRIC)

SIZE	MIN.FLOW RATE
65mm	46.5 LPM (Liters per minute)
80mm	58.8 LPM
